Name Of Dam: SOUTH RIVER NO. 27

Inventory Number: VA 01503

PHASE I INSPECTION REPORT

NATIONAL DAM SAFETY PROGRAM

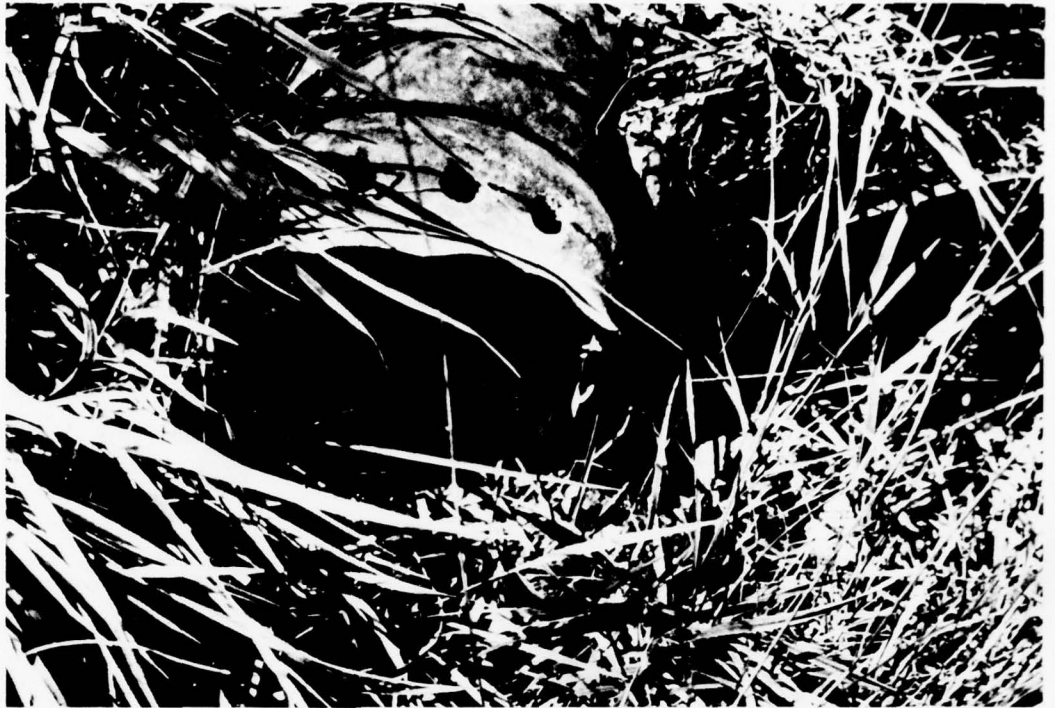
PHOTO 1. Left Seepage Drain

- 1.2.1 Description of Dam and Appurtenances: South River Dam No. 27 (Upper Sherando Lake Dam) is an earthfill structure about 950 feet long and 60 feet high. The top of the dam is 17 feet wide and is at elevation 1950.0 feet above Mean Sea Level (M.S.L.). Side slopes are two and one-half horizontal to one vertical (2.5:1) seepage control is provided by an impervious core key way extending one foot into bedrock. A toe drain outletting adjacent to the outlet pipe has been provided (Photo 1).

Small trees (approximately six feet high) were observed growing on both faces of the dam. Two large animal burrows are located on the downstream face of the dam slightly above the outlet conduit. Another animal burrow is located immediately adjacent to the seepage drain outlet on the north side of the principal spillway outlet. The rubble tossed aside from this burrow has blocked the outlet of this seepage drain.

- 1) The trees growing on the embankment should be removed.
- 2) The footpaths on the upstream and downstream faces of the dam should be repaired and reseeded, or a type of stairway should be constructed to prevent future damage.
- 3) Continuous drainage should be restored along the berm on the downstream face of the dam by removal of sediment from the footpaths and regrading.
- 4) The animal burrows, particularly the burrow adjacent to the left seepage drain outlet, should be backfilled. The seepage drain outlet should be cleaned.

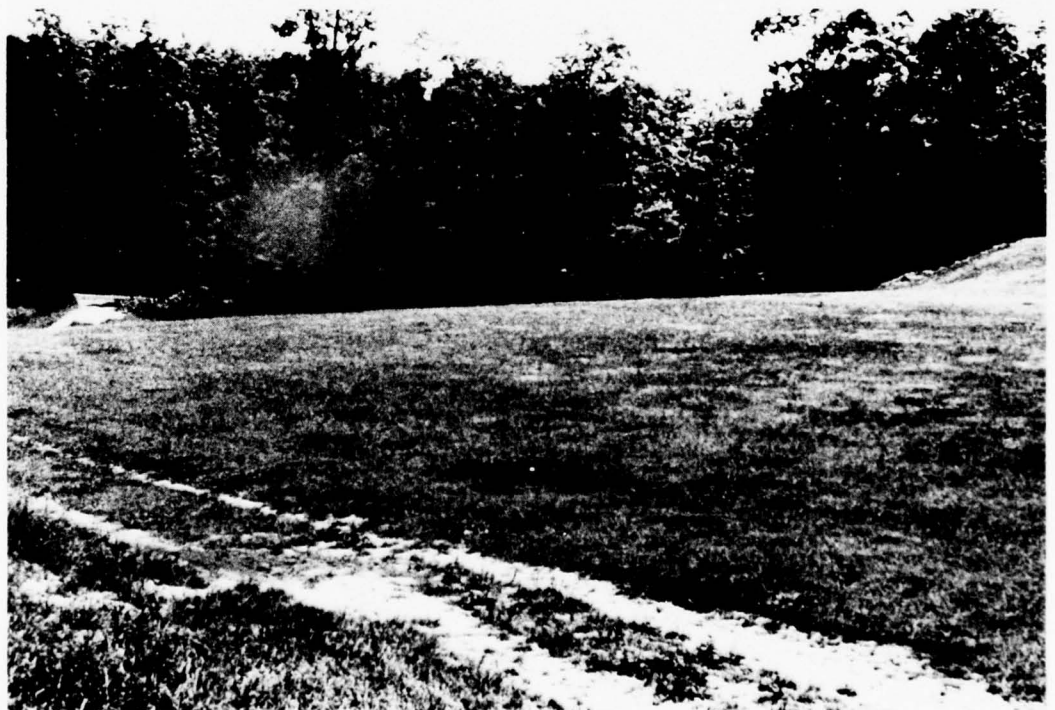
PHOTO 2. Emergency Spillway

- The emergency spillway (Photo 2) is a vegetated, rock-cut, side-channel type with a bottom width of 160 feet. It has side slopes of 3:1 and 2.5:1, respectively. The crest of the emergency spillway is at elevation 1942.7.

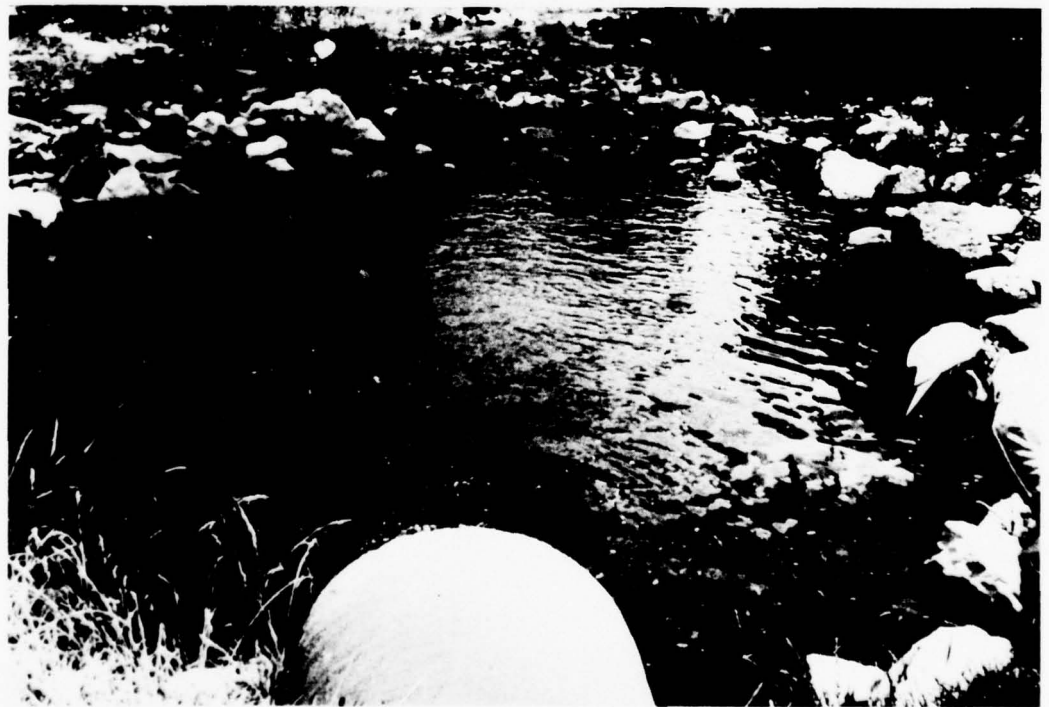
PHOTO 4. Outlet Pipe and Stilling Basin

3.1.5 Downstream Channel: The outlet pipe is in good condition and is functioning properly (Photo 4).
